## IDAHO CAPITOL RESTORATION

Department of Administration  
Construction Update No. 52  
September 19, 2005

## Eagle Gilding Complete; Stone, Masonry Repair Continues; Workers Focus On Windows, Skylights

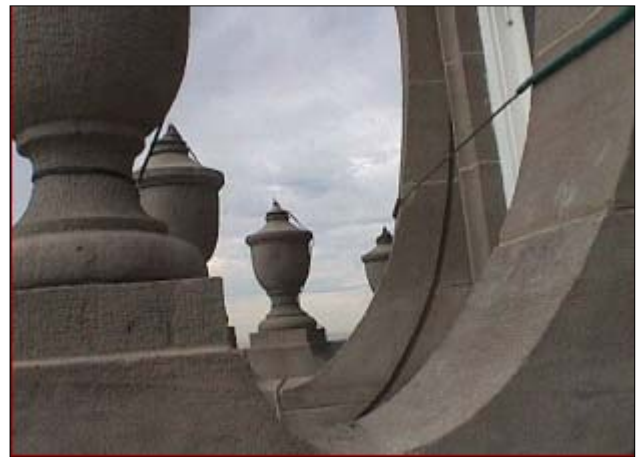
**At one time, lighting fixtures were attached to the urn edifices surrounding Dome at Urn Level.**

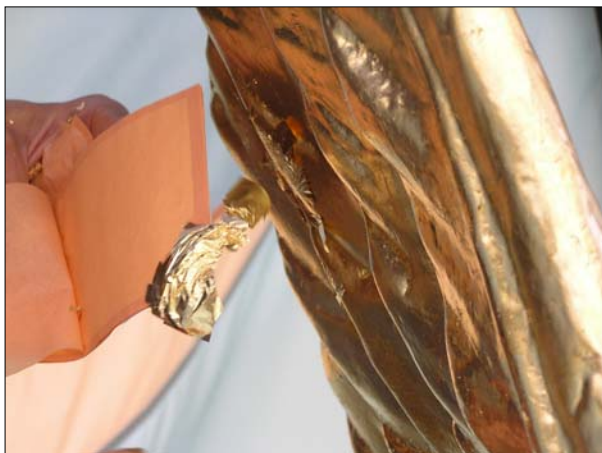
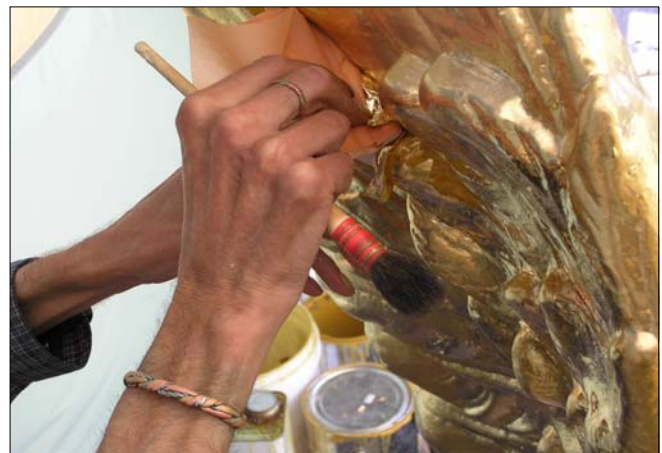
**Boise Artist Michael Kobold** of Raggle Day Studios applies the thin layers of gold leaf, using a brush and static electricity to create a magnetic-like surface on the eagle's exterior to capture the very fine layer of gold (**photos below**). A tent provided both the artist and the statue protection from the wind and elements during the process.

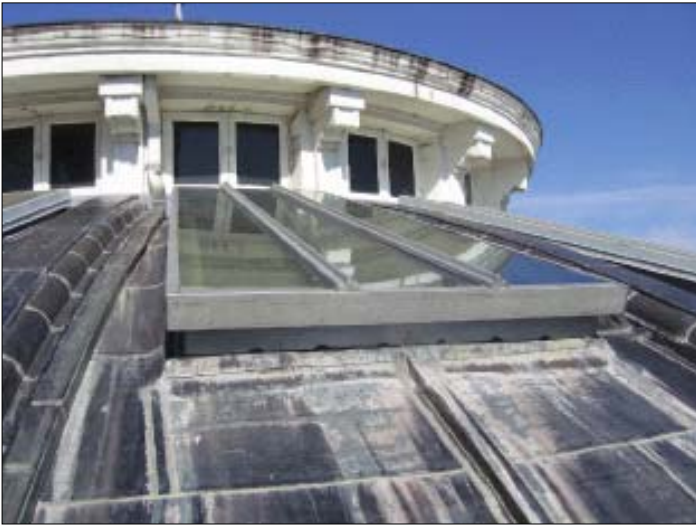
**Skylight unit atop West Cupola of Capitol.**

Workers are also verifying and analyzing conditions and repair needs for the Capitol's varied skylights and their supporting structures, drainages, insulation and sealants.

The skylight repair work will need to be completed prior to the DPW re-roof project scheduled for next spring.

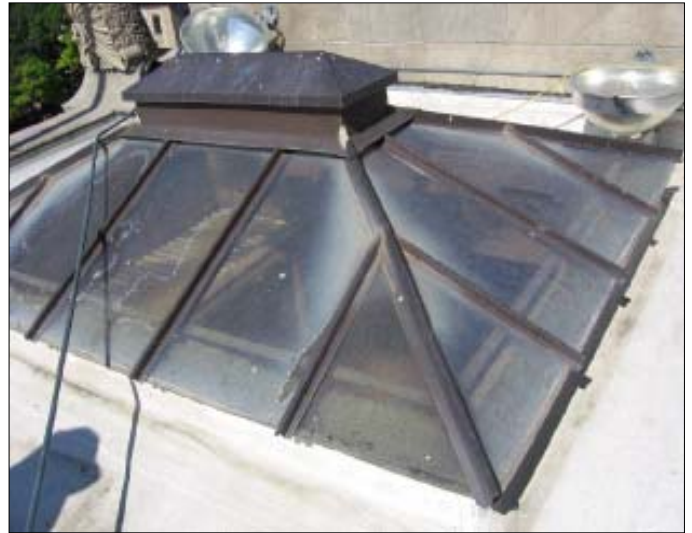
**Steel and Copper skylight unit.**

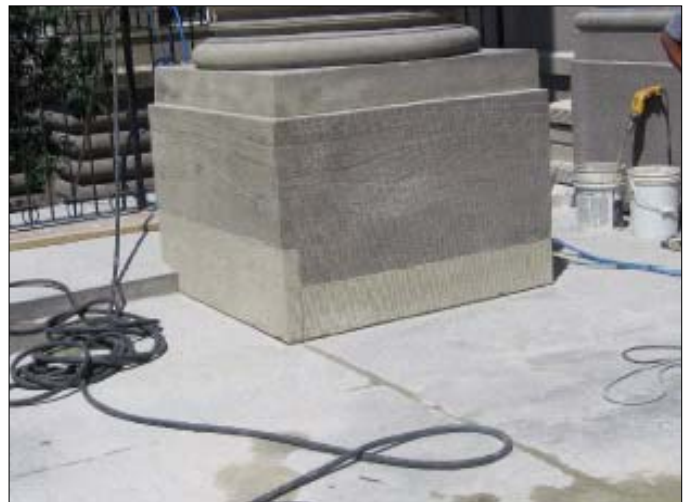
**Dutchman column repairs at South Entry.**

Other work in progress includes Dutchman column pedestal repairs at the South Entry of the Capitol. Contractors are also addressing repair needs for the wrought iron guardrails and ornamental outriggers at the South Stairs.
